Draft Detailed Project Report with Integrated Environmental Assessment

Little Miami River, Loveland, Ohio
Continuing Authorities Program (CAP) Section 14
Emergency Streambank Stabilization Project

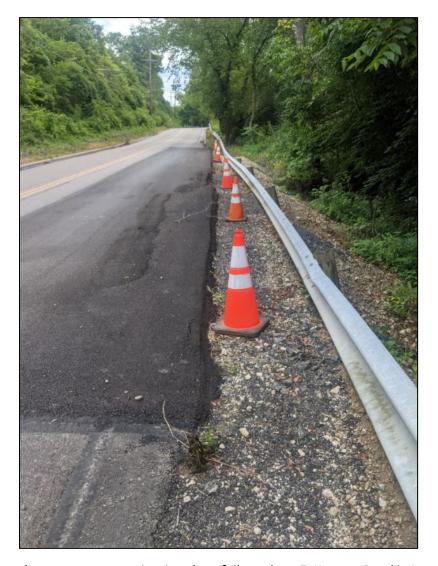
Photo above shows an area experiencing slope failure along E. Kemper Road in Loveland, Ohio

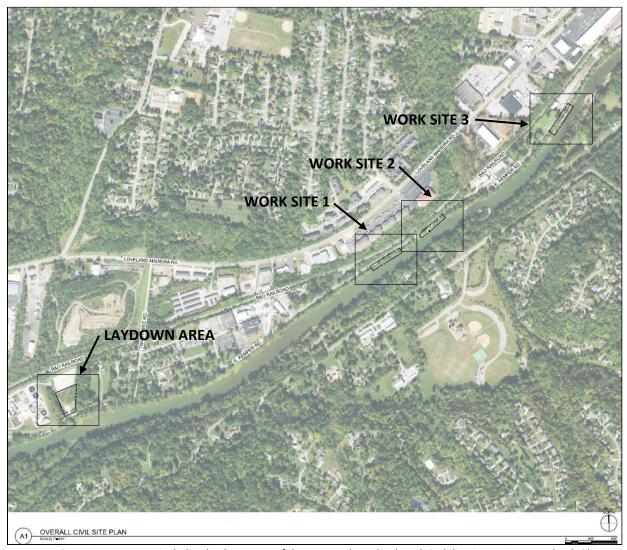
Figure 3. Project Area Map including laydown area of the proposed Loveland Bank Stabilization Project, Loveland, Ohio.

A Project Area map including the three work sites and the laydown area is shown in Figure 3. Additional details regarding the laydown area can be found in Section 6.2 and Appendix D.

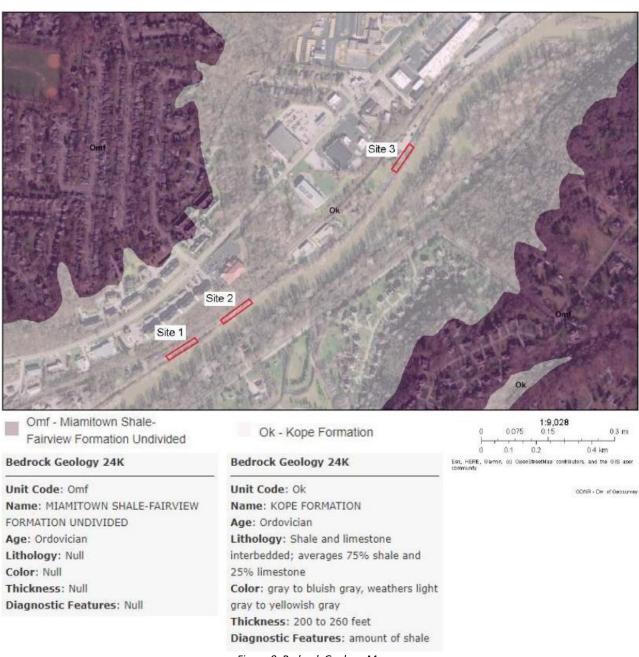
Figure 8. Bedrock Geology Map

The Kope Formation is found throughout the state of Ohio. According to the Ohio Geology Interactive Map of the Ohio Department of Natural Resources, the three erosion sites are underlain by the Kope Formation that belongs to the Ordovician Age and includes shale and limestone interbedded with an average of 75% shale and 25% limestone (Figure 8).

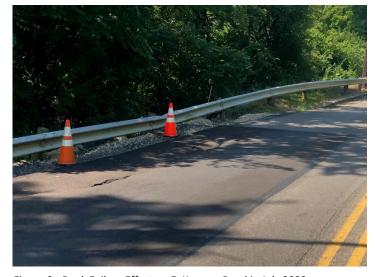
Figure 9 - Bank Failure Effect on E. Kemper Road in July 2023

Without any intervention, it can be assumed that the bank will continue to experience slope failures and erode at a similar rate as has been observed over the past 10-20 years (Figure 9). The active slope failures of the streambank would continue unabated and eventually undermine the soils below E. Kemper Road. This will either result in the eventual full collapse of the highway into the Little Miami River or in the demolition of part of the highway sometime before the highway collapses into the River. In the former scenario, some form of cleanup project would be needed to remove roadway materials from the Little Miami River.

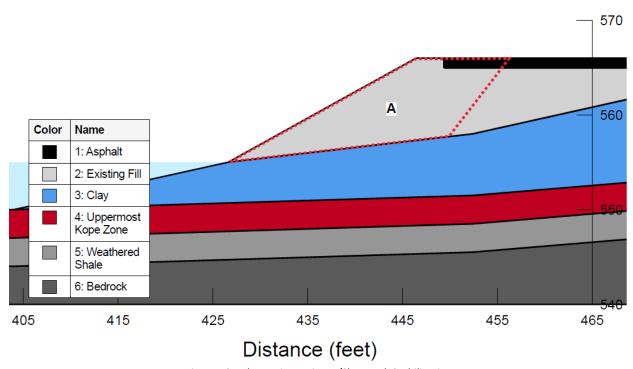
Figure 10 - Alternative 1 Riprap/Shot Rock Stabilization

to 1 vertical (1H:1V) slope until undisturbed native soils are encountered. For constructability, Zone A would likely be extended to include the materials supporting the storm sewer. The removed materials in Zone A would be replaced with riprap and shot rock to restore the slope. A 2H:1V outer slope between E. Kemper Road and Little Miami River would be created for the three sites with crushed stone consisting of riprap and shot rock properly benched into the underlying undisturbed soils (sizes of the benches will depend on the grade revealed when removing the existing fill) and the 1H:1V existing fill slope (typical benches would be 1H:1V but will be determined during the design phase). Shot rock will be used to reconstruct most of the remediated areas with riprap placed on the outer slopes along the Little Miami River. The riprap should be sized to the anticipated velocities of the Little Miami River to protect the slope from erosion. A choke stone should be placed over the shot rock to provide a working surface for the stone base course of E. Kemper Road. In utility areas, consider bedding utilities and backfilling utility trenches with controlled low-strength material (CLSM). CLSM is a low strength concrete material. Use of this as bedding and backfill of utilities reduces the risk of loss of support of the utility through material loss within the utility and into the surrounding crushed stone. Potential future failures within the underlying low strength zone of the Kope Formation would disturb the remediated stone slope. However, crushed stone such as riprap and shot rock used to initially remediate the slope should be suitable to be used to reconstruct the slope. Additionally, depending on the nature of a slope failure, the resulting slope and residual strength of the crushed stone may be sufficient that only a slight modification of the disturbed slope would be necessary to restore stability. The construction cost for riprap/shot rock at a conceptual level is estimated to be \$4,370,000 (FY2024). See Figure 11 below.

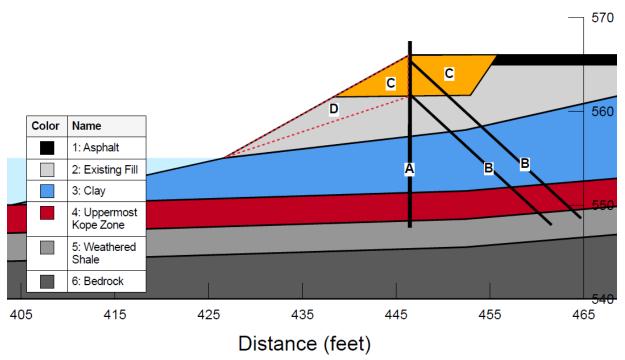
Figure 11 - Alternative 2 Wall with tieback anchors

Assuming that the riverside soils in Zone C were replaced during construction, the wall design still must account for the erosional losses in Zones C and D (area included in the red dashed line), the weakened properties of Zone D, and the steep slope on the river side of the wall. This condition with the relatively thin layer of soils (approximately 10 feet of existing fill and native clay) and uppermost Kope zone (approximately 3 feet) overlying the weathered shale would likely require the wall to be reinforced with anchors. In addition, portions of the system (anchors and or sheet piles) would be susceptible to material loss over time from corrosion. This method of repair would only address the upper slope adjacent to the road. Potential future failures within the underlying low strength zone of the Kope formation would damage the wall system and require reconstruction of the wall. The cost for a wall with tieback anchors at a conceptual level is estimated to be \$6,150,000 (FY2024). See Figure 12 below.

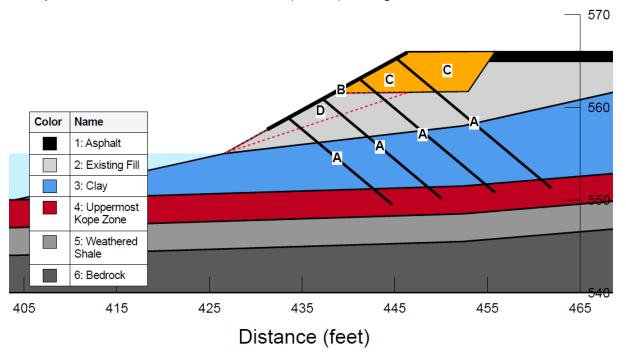
Figure 12 - Alternative 3 Soil Anchor reinforcement

storm sewer. The weaker residual strength soils in Zone D would remain. The anchors and reinforcing mat would be used to stabilize the soils of the upper slope. It is estimated that approximately 366 soil nails will be needed and installed in a systematic pattern to stabilize the existing bank slope. As with the wall system, portions of the system (anchors and reinforcing mat) would be susceptible to material loss over time from corrosion. This method of repair would also only address the upper slope adjacent to the road. Potential future failures within the underlying low strength zone of the Kope formation would damage the anchor system and require reconstruction. The cost for soil anchor reinforcement at a conceptual level is estimated to be \$4,580,000 (FY2024). See Figure 13 below.

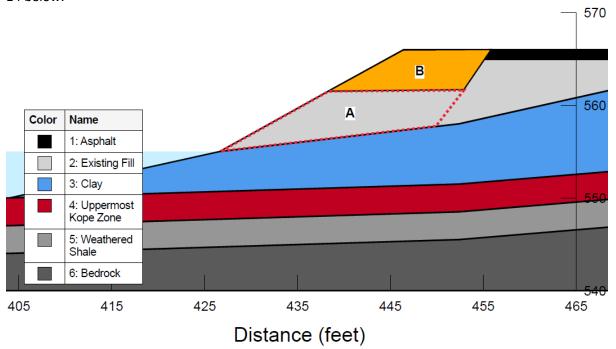
Figure 13 - Alternative 4 Chemical Grouting

require additional chemical grouting or other remediation methods to restore the stability of the slope. The cost for chemical grouting at a conceptual level is estimated to be \$9,500,000 (FY2024). See Figure 14 below.

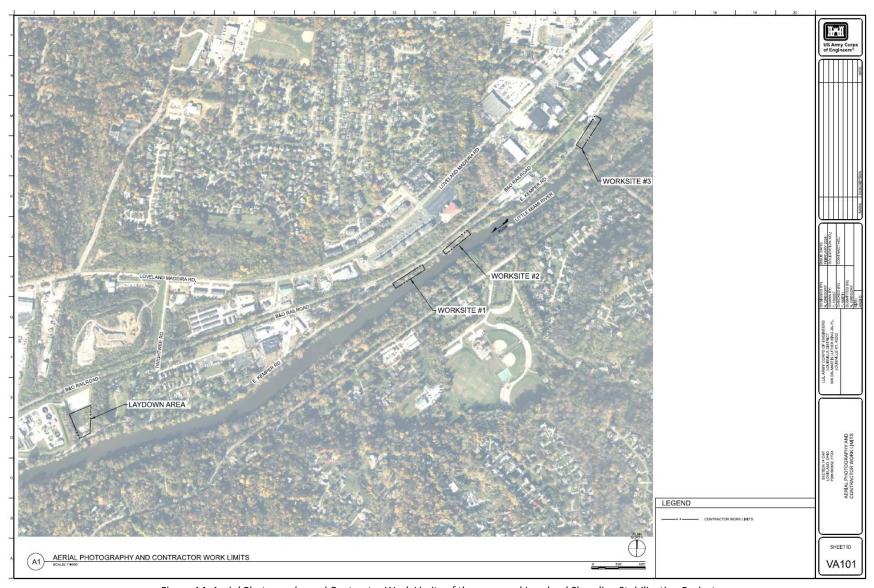
Figure 14. Aerial Photography and Contractor Work Limits of the proposed Loveland Shoreline Stabilization Project.

Implementation of the TSP must comply with the requirements associated with the Little Miami River's designation as a Recreational River Area. Vegetated riprap was chosen to accomplish this by limiting the visibility of the riprap and preserving the aesthetic value of the Project Area. After placement of the riprap, slurry comprised of a mixture of water and topsoil will be pumped into the surface voids of the riprap. After placement of the slurry, topsoil will be placed to create a smooth surface that will support vegetative growth. The topsoil will be reseeded with native grasses and plants and reseeding techniques suitable for the application and site conditions. As part of ongoing operations and maintenance of the Project, large trees will not be allowed to establish in the riprap as this would compromise the integrity of the Project (Section 6.4).

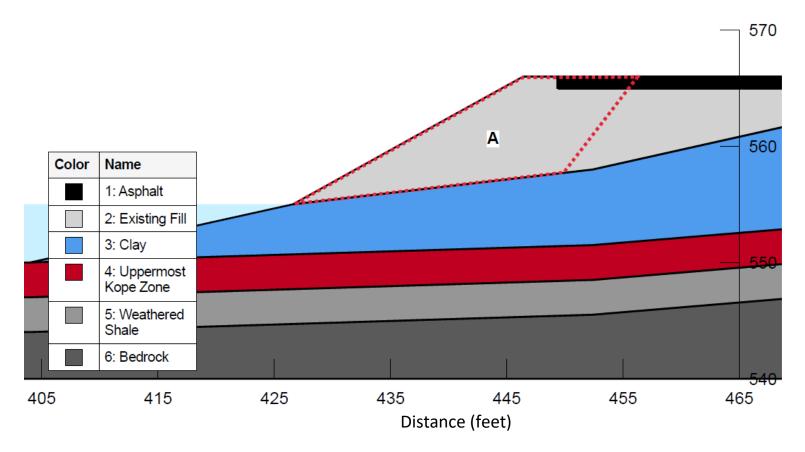
A – Minimum zone of soils replaced with riprap/shot rock.

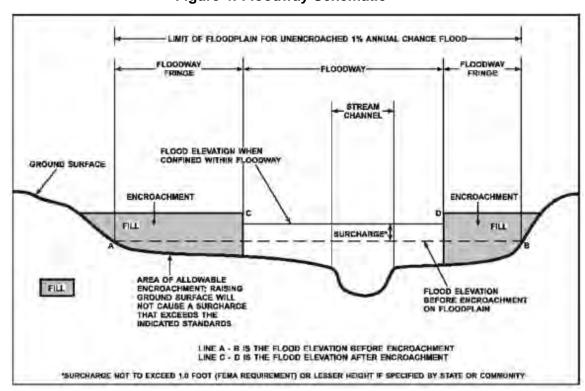
Figure 4: Floodway Schematic

To participate in the NFIP, federal regulations require communities to limit increases caused by encroachment to 1.0 foot, provided that hazardous velocities are not produced. The floodways in this project are presented to local agencies as minimum standards that can be adopted directly or that can be used as a basis for additional floodway projects.

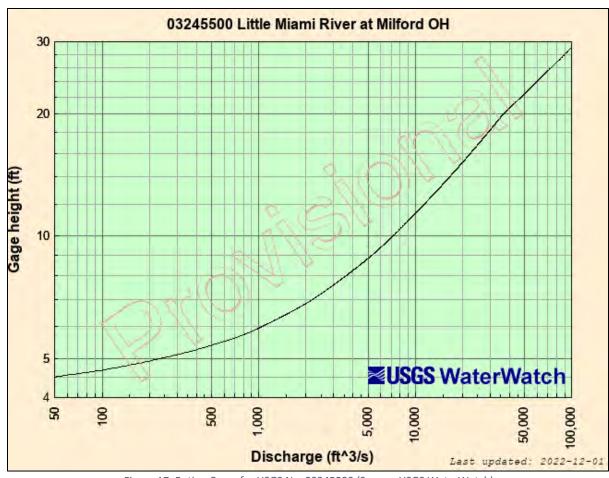
The downstream boundary condition was set to a rating curve based on the USGS WaterWatch rating curve for USGS Gage No. 03245500 Little Miami River at Milford, Ohio, accessed May 26th, 2022; See Figure 17. Note that the rating curve was trimmed to only include flows at or near the 100-year flood event, or 1% annual exceedance probability flows (AEP); The rating curve will need to be updated for any future studies.

Figure 17: Rating Curve for USGS No. 03245500 (Source: USGS WaterWatch)

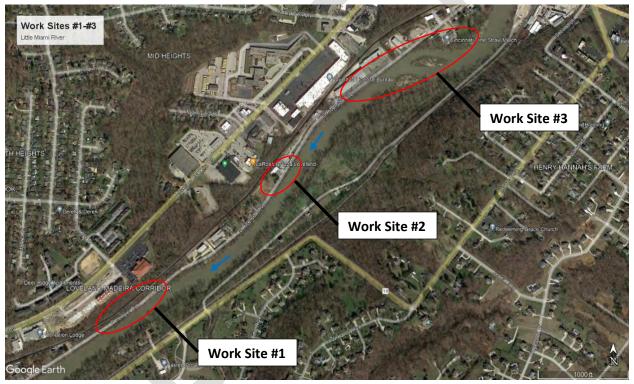
The plan for the site visit was originally to include kayaking the sites to be able to see the locations from the river view. The water level was too high for safely navigating the river so land access along the narrow road corridor was completed. There are three main Work Sites located in the reach and are identified in Figure 1.

Figure 1: Little Miami River, Loveland, OH Works Sites 1-3 (all RT Bank erosion). Work Site 3 extends upstream into channel bendway (Rt Bank).

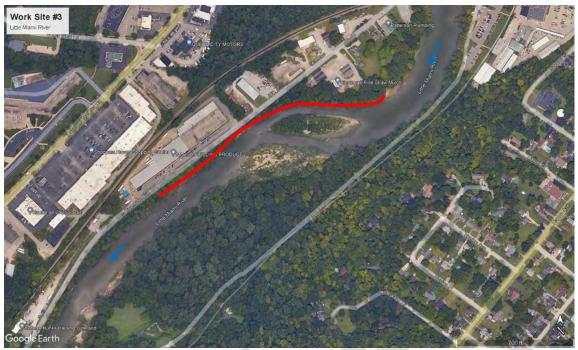
**Work Site 3 (Upstream):** This site originates upstream of the center channel bar and ends where stable vegetation and rock materials are present in the right bank margins (Figure 2). The total extent of the upstream erosion was not field verified due to high water. However, based on previous experience this is likely the location to tie in a revetment to stable channel conditions. The downstream extent is also estimated due to high water conditions and should be field verified once water levels are low enough to verify.

Figure 2: Little Miami River, Loveland, OH Work Site 3 (RT Bank erosion). Work Site 3 extends upstream into channel bendway (Rt Bank).

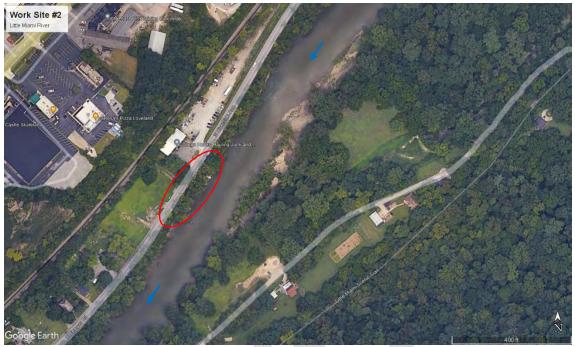
out of materials that surround the conduits. As the winnowing out of materials continue the overlying infrastructure (roadway) bevels out and fails with lack of foundations support.

Figure 4: Little Miami River, Loveland, OH Work Site 2 (College Hunks Hauling parking lot).

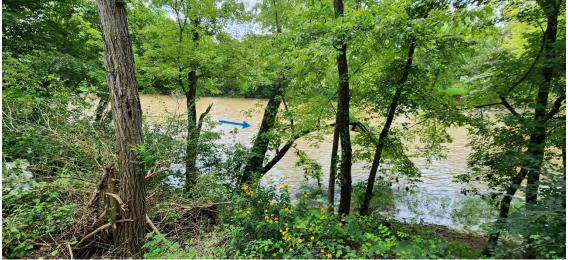
The right bank showed no signs of erosion as illustrated in Figure 5. The erosion issue at this site is being caused by the local storm sewer conduit.

Figure 5: Little Miami River, Loveland, OH Work Site 2 illustrating stable right bank conditions.

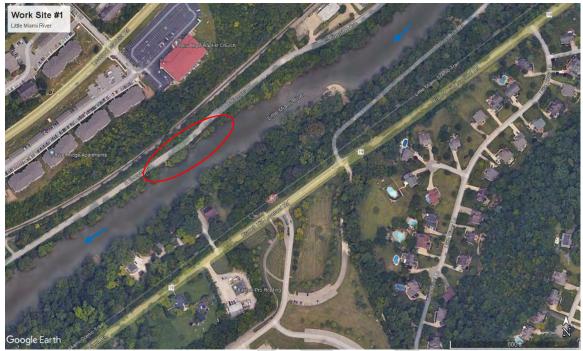
Figure 6: Little Miami River, Loveland, OH Work Site 1 (Downstream site).

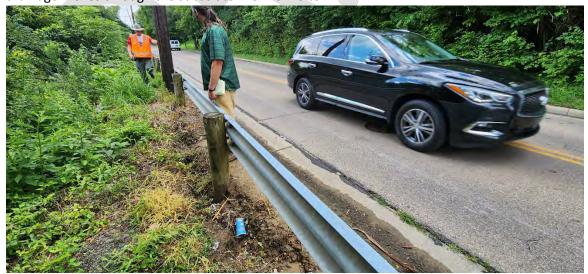
Tension cracks in the soil parallel with the roadway and guardrail were identified as illustrated in Figure 7. This area of roadway appears to have recent curb and gutter repairs and roadway drainage may be causing the local instability (Storm Sewer outlets?). The location appears to be a low point in the roadway drainage which may be causing road shoulder erosion and settling of the shoulder materials as drainage moves through the substrate like Work Site 2.

Figure 7: Little Miami River, Loveland, OH Work Site 1 (Downstream site) illustrating tension cracks at the edge of the roadway/guardrail.

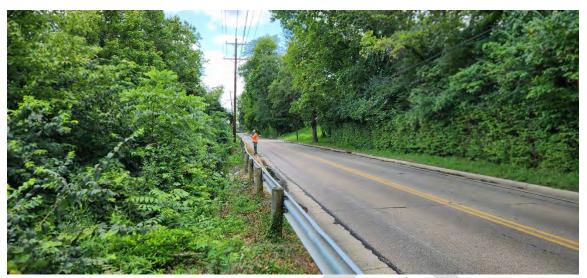
Figure 8: Little Miami River, Loveland, OH Work Site 1 (Downstream site) illustrating uneven roadway edge and guardrail.

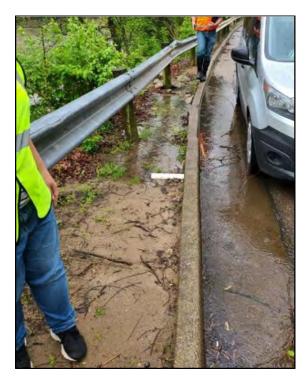
Evidence of past slope failure at Site 2 included leaning trees, settlement of the outer portion of E. Kemper Road, and stone/concrete debris placement for assumed repair attempt(s) on the slope between E. Kemper Road and Little Miami River. Small drainage pipes penetrating the curb on the southeast side of East Kemper Road were reportedly installed to help prevent ponding of water on the road due to localized settlement (Figure 9).

Figure 9: Small Drainage Pipes Penetrating the Curb on the Southeast Side of E. Kemper Road

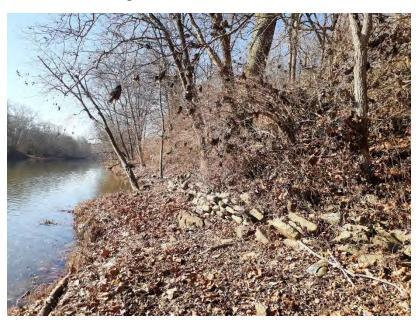
A cultural resources survey was conducted on December 14, 2023, by Jared Barrett of CELRL-PMC-WPL. A dry laid limestone terrace approximately two and half feet high and 46 feet long was discovered on the northeastern edge of Site 2 near the Little Miami River (Figure 10). It was assumed that the terrace was near or below the Little Miami River water elevation at the time of the site reconnaissance conducted on April 29, 2021.

Figure 10: Dry laid limestone terrace at northeast edge of Site 2 (looking southwest)

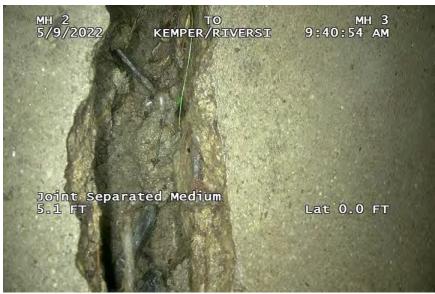
Tele-Vac Environmental conducted Closed-Circuit Television Video (CCTV) and Pipeline Assessment and Certification Program (PACP) inspections on the storm sewer lines at the three erosion sites on May 9, 2022. The inspections revealed significant joint separations and movement within the storm sewer lines and indicated there may be significant loss of material from joint separations and offsets, which also gave roots the opportunity to penetrate the storm sewer. The captured images also indicated that significant erosion near the open/damaged sections of the storm sewer had taken place. The presence of voids at these areas shows a significant loss of material around the pipe joints, although it is not an indicator of absolute material loss as there may be voids behind the material shown that cannot be determined without some form of investigation or ground penetrating radar. The locations of the storm sewer lines are shown on the Storm Sewer Lines Location Map included in Attachment F. CCTV Inspection Photos are included in Attachment F and selected photos for Sites 1, 2, and 3 are shown in Figure 11, Figure 12, and Figure 13, respectively.

Figure 11: Joint Separation at Site 1

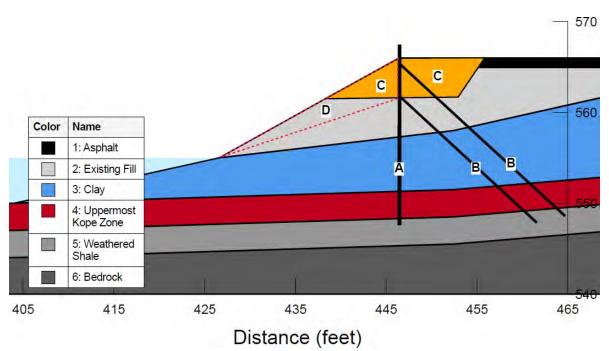
#### **Wall with Tieback Anchors**

- A Wall (sheet pile or post and panel).
- B Tieback Anchors.
- C Minimum zone of material anticipated to be removed for the repair of the storm sewer.
- D Weakened zone of soils in residual strength due to past failure(s).

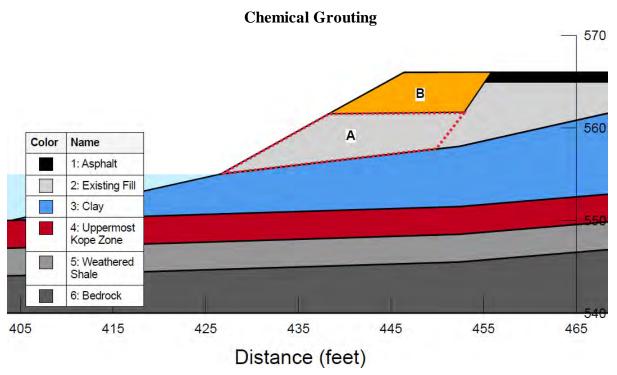
A – Chemically Grouted Soils.

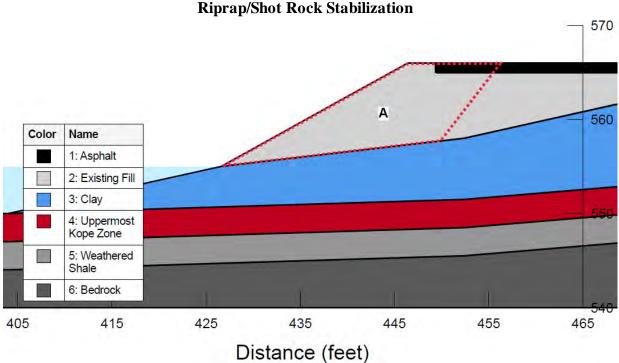
## 2.18.4. Alternative 4 – Riprap/Shot Rock

A – Minimum zone of soils replaced with riprap/shot rock.

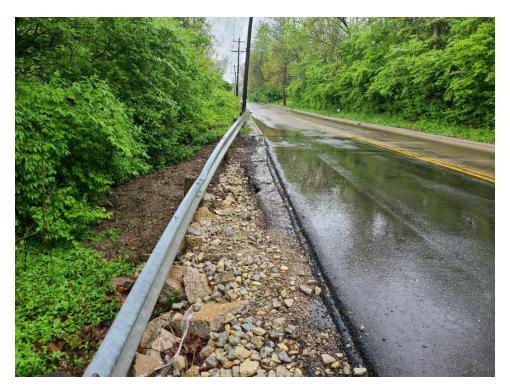
**Photo 1 (Site 1):** Guard rail movement, asphalt settlement and resurfacing, and stone placement for erosion repair on the southeast side of E. Kemper Road (looking southwest).

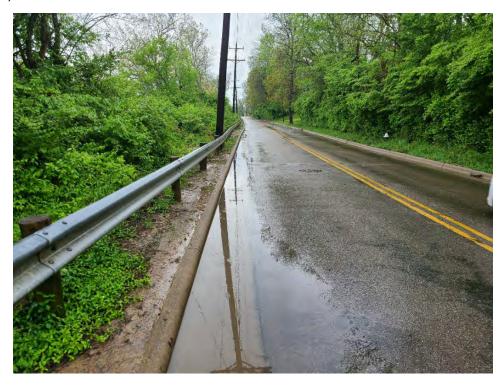
**Photo 2 (Site 1):** Water ponding on the southeast side of E. Kemper Road (looking southwest).

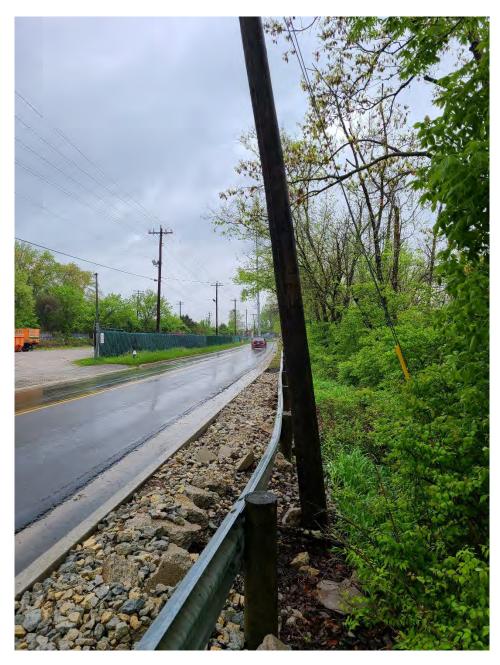
**Photo 8 (Site 3):** Guard rail movement, leaning light pole, and stone placement for repair on the southeast side of E. Kemper Road (looking northeast).

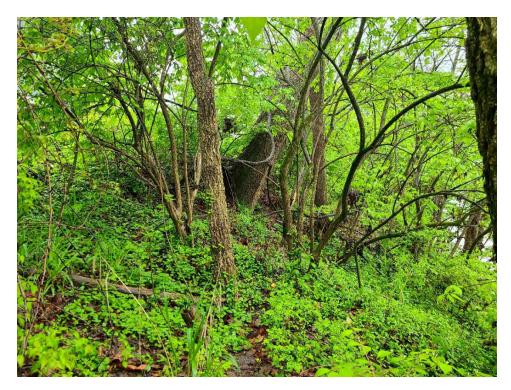
**Photo 9 (Site 3):** Leaning tree on slope between E. Kemper Road and Little Miami River (looking northeast).

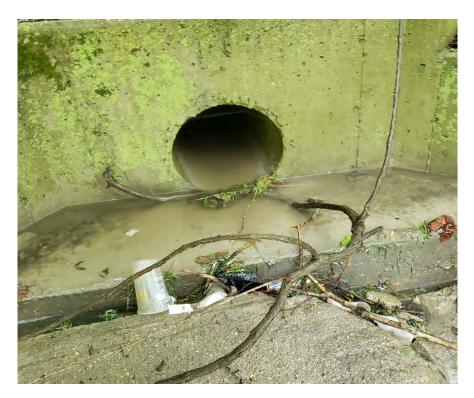
**Photo 11 (Site 3):** Silty sand soils observed in a storm sewer pipe at a headwall located on the slope between E. Kemper Road and Little Miami River (looking northwest).

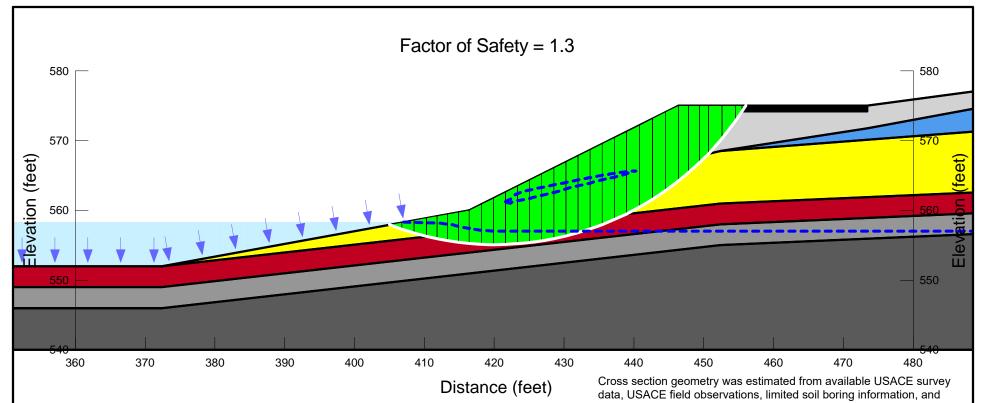
Color	Name	Slope Stability Material Model	Unit Weight (pcf)	Effective Cohesion (psf)	Effective Friction Angle (°)
	1: Asphalt	Mohr-Coulomb	145	0	40
	2: Existing Fill	Mohr-Coulomb	125	50	22
	3: Clay	Mohr-Coulomb	130	200	23
	4: Clayey Sand	Mohr-Coulomb	120	100	27
	5: Upper Kope Zone	Mohr-Coulomb	140	140	13
	6: Weathered Shale	Mohr-Coulomb	140	200	15
	7: Bedrock	Bedrock (Impenetrable)			
	8: Riprap	Mohr-Coulomb	135	10	40

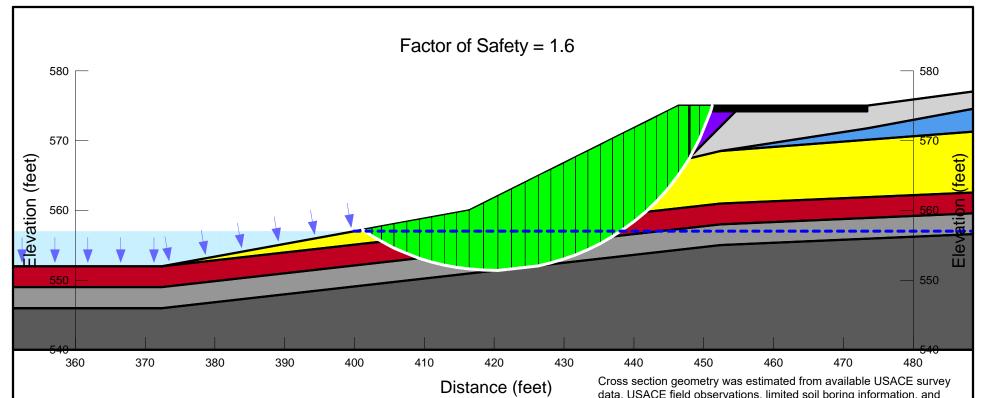
Color	Name	Slope Stability Material Model	Unit Weight (pcf)	Effective Cohesion (psf)	Effective Friction Angle (°)
	1: Asphalt	Mohr-Coulomb	145	0	40
	2: Existing Fill (Undrained)	Mohr-Coulomb	125	800	0
	3: Clay (Undrained)	Mohr-Coulomb	130	1,000	0
	4: Clayey Sand (Undrained)	Mohr-Coulomb	120	500	15
	5: Upper Kope Zone	Mohr-Coulomb	140	140	13
	6: Weathered Shale	Mohr-Coulomb	140	200	15
	7: Bedrock	Bedrock (Impenetrable)			
	8: Riprap	Mohr-Coulomb	135	10	40

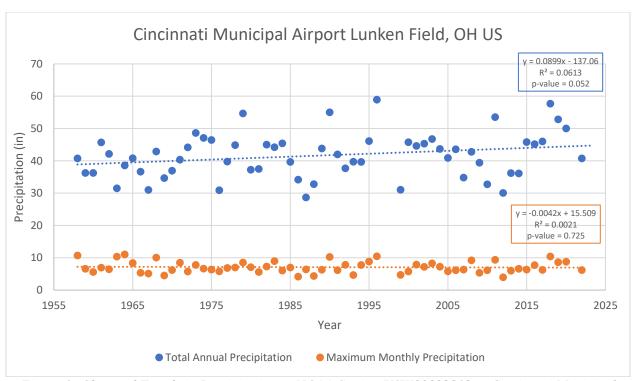
Figure 1: Observed Trends in Precipitation at NOAA Station USW00092812 at Cincinnati Municipal Airport Lunken Field, OH

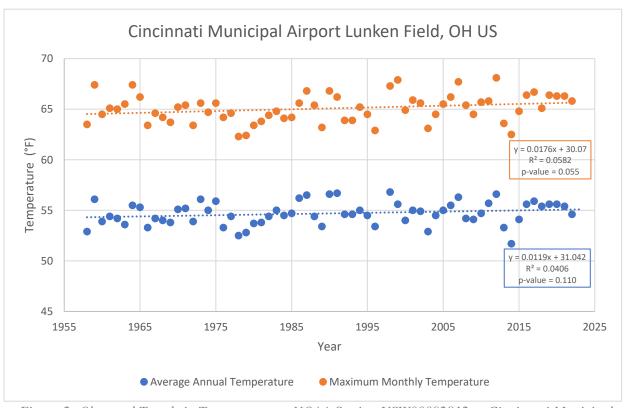
Figure 2 displays average annual temperatures and annual maximum monthly temperatures which were derived from daily temperature records. Note that both average annual and annual maximum monthly temperatures exhibit increasing trends over time. The magnitude of the average annual temperature's increasing trend is 0.0119 °F/year. Meanwhile, the average annual maximum temperature's increasing trend is roughly 0.0176 °F/year. Both are relatively small compared with annual variability in temperature. Additionally, the trends' magnitudes are relatively small, the p-values for both datasets (0.110 for average annual maximum temperatures and 0.055 for average annual temperatures) indicate that these trends are statistically significant.

Figure 2: Observed Trends in Temperature at NOAA Station USW00092812 at Cincinnati Municipal Airport Lunken Field, OH

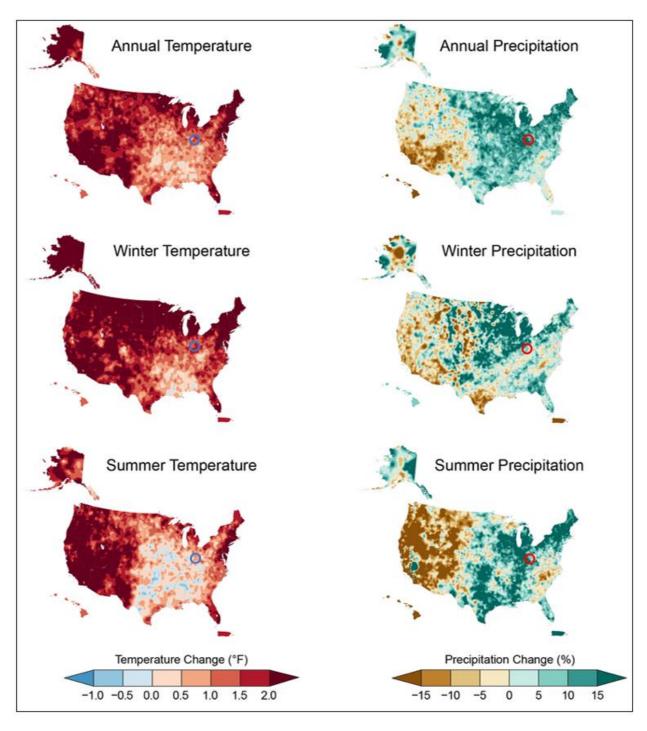
While heatwaves are becoming for frequent globally, the number of very hot day (days over 95°F) for the central and eastern United States as decreased. Additionally, cold days has decrease by 5 days (days below 32°F) and warm nights (number of nights bellow 70°F) have increased by 0.6 days for the Midwest.

Figure 3: Observed Changes in Annual, Winter, and Summer Temperature and Precipitation

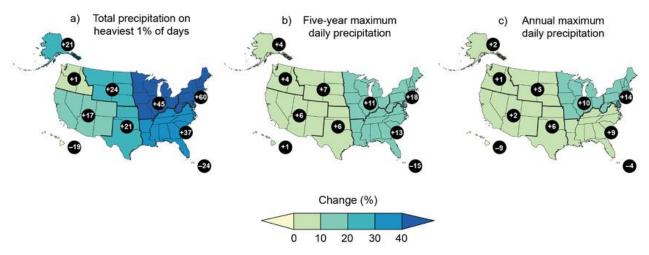
Since the 1950s an increase trend in heavy precipitation has been experienced across the US. The increasing trend is a result from more frequent precipitation extremes with smaller changes in the intensity of the extreme precipitation events. Figure 4 displays the percentage change in observed total precipitation on heaviest 1% of days, five-year maximum daily precipitation, and the annual maximum daily precipitation. For all three of the observed changes an increase was found for the Midwest with the total precipitation on heaviest 1% of days having the largest increase (increase of 45%).

Figure 4: Observed Changes in Precipitation

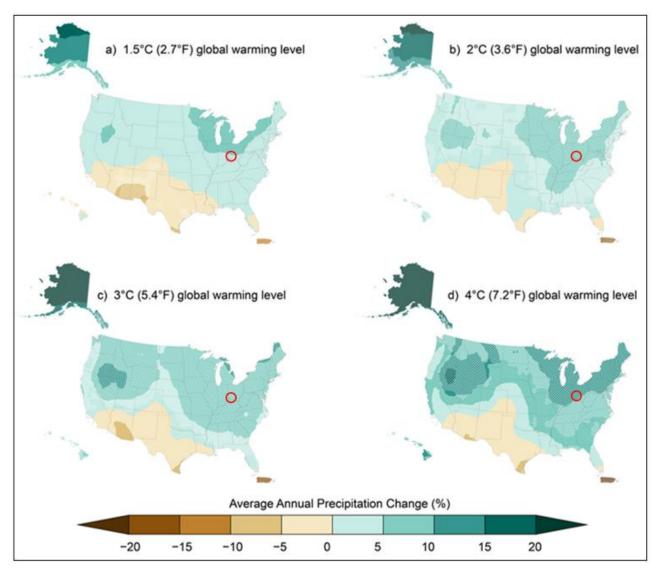
*Precipitation: The NCA5 noted* precipitation changes are less certain than temperature changes. For the eastern US annual average precipitation is very likely to increase as global temperatures increase. Figure 9 shows the projected changes in average annual precipitation for different GWL. Areas with hatching indicate where 80% or more of models agree on the sign of the change. As temperatures increase average annual precipitation increases for Loveland Ohio in all of the global warm levels. For the three higher GWL, Loveland Ohio's average annual precipitation are located in areas with hatching.

Figure 9: Projected US Precipitation Changes at 1.5°C, 2°C, 3°C, and 4°C of Global Warming

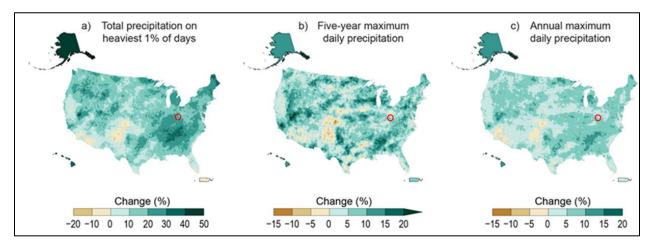
Figure 10: Projected Changes to Total Precipitation on Heaviest 1% of Days, Five-year Maximum Daily Precipitation, and Annual Maximum Daily Precipitation for 2°C of Warming.

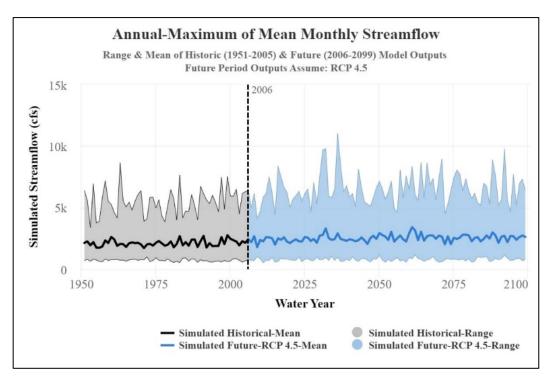
Figure 12: Range of Annual- Maximum of Mean Monthly Streamflow RCP 4.5 GCM projections for Stream Segment ID: 05003655 of Little Miami River, HUC 05090202
