STANDARD OPERATING PROCEDURE FOR

VEGETATION REMEDIATION AND REMOVAL (23 November 2021)

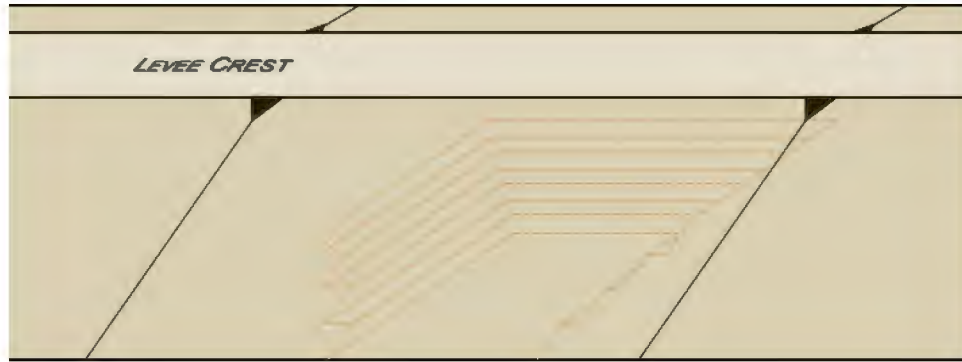
Figure 5: The excavation is backfilled and trimmed to allow topsoil placement to the design slope.

The materials and placement procedures used to backfill the excavation must be in accordance with “SOP-General Earthwork Associated with Levees” to beyond the face of the slope to ensure that any insufficiently compacted material is removed when the fill is cut back in preparation to receive the topsoil for final grading (Figure 5).
